Enforcement Sensitive - Falcon Refinery Site Visit: January 14, 2015

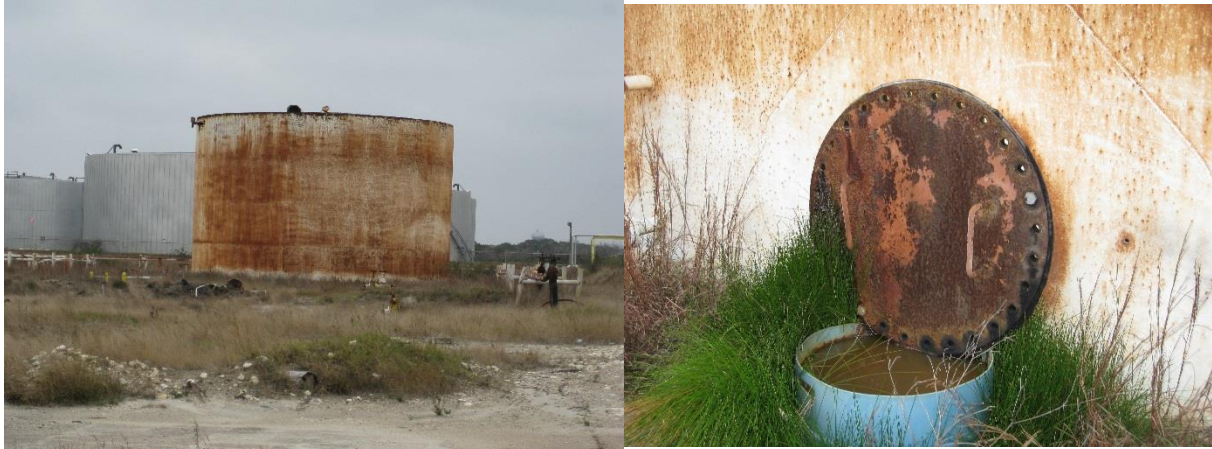
Tank 7: Notice only 2 manway bolts would indicate tank material removed and only water is still in tank about $\frac{3}{4}$ way up the manway.

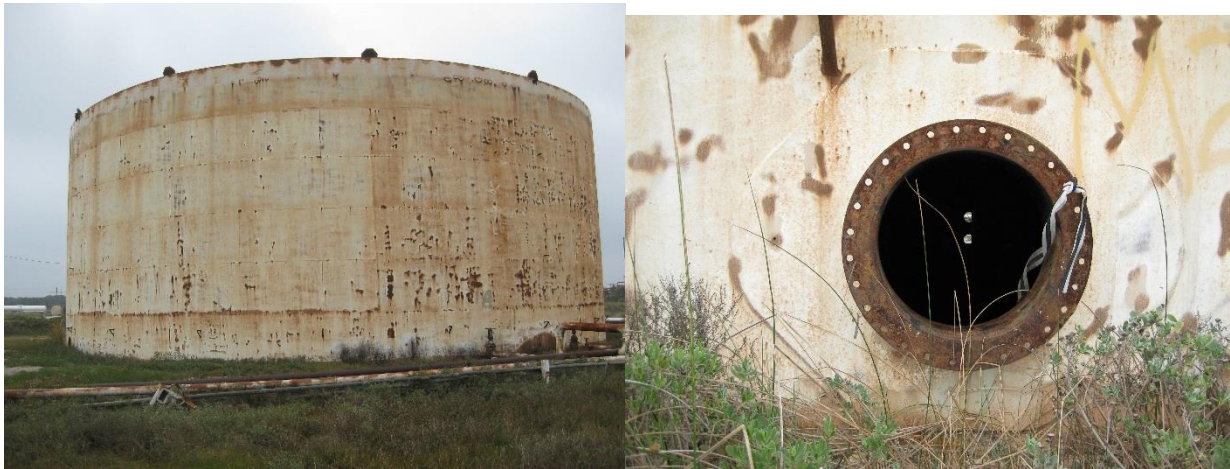
Tank 12: Tank with open manway. Appeared that it was about 6 – 12 inches of water.

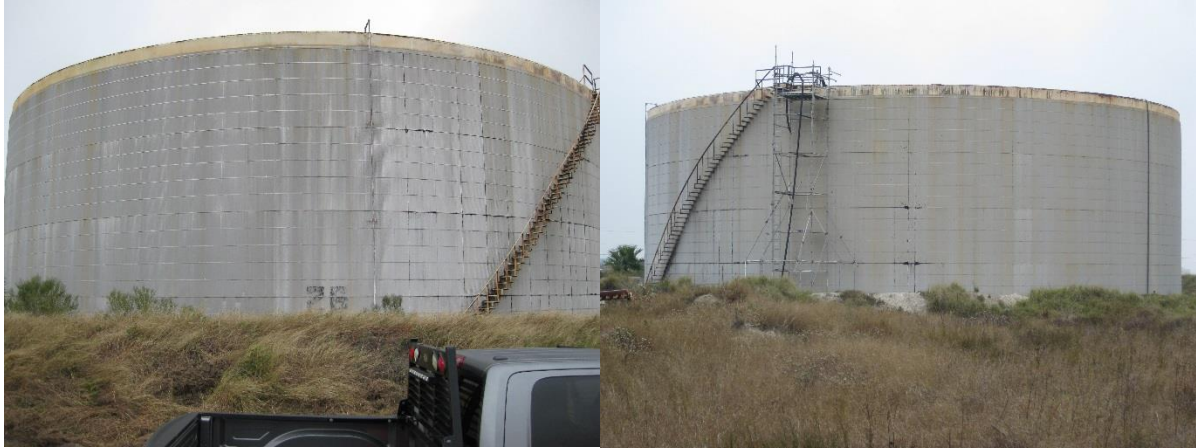
Tank 26: Insulated Tank – Volume of material in tank is unknown

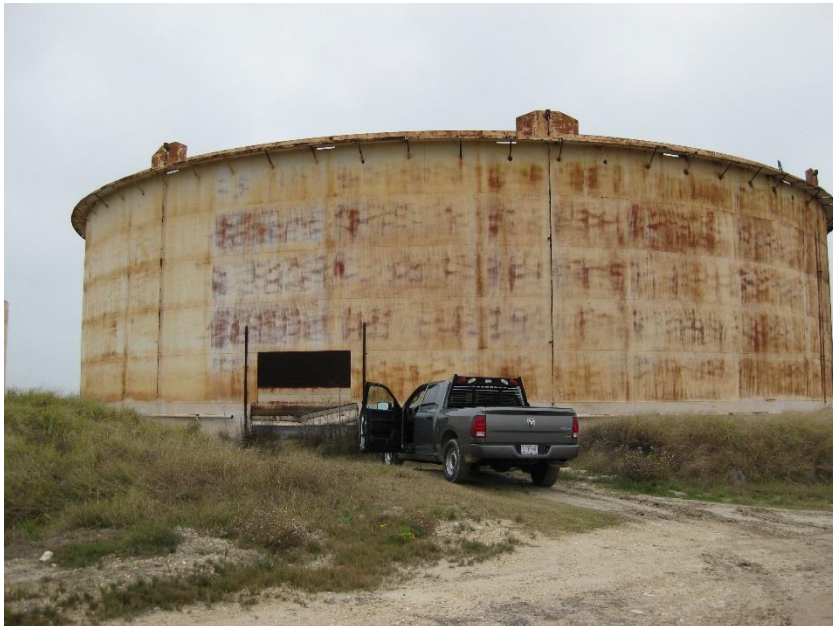
Tank 30: Big Hole in Tank with about 2 feet of Sludge and Water and portion of floating roof on the floor.

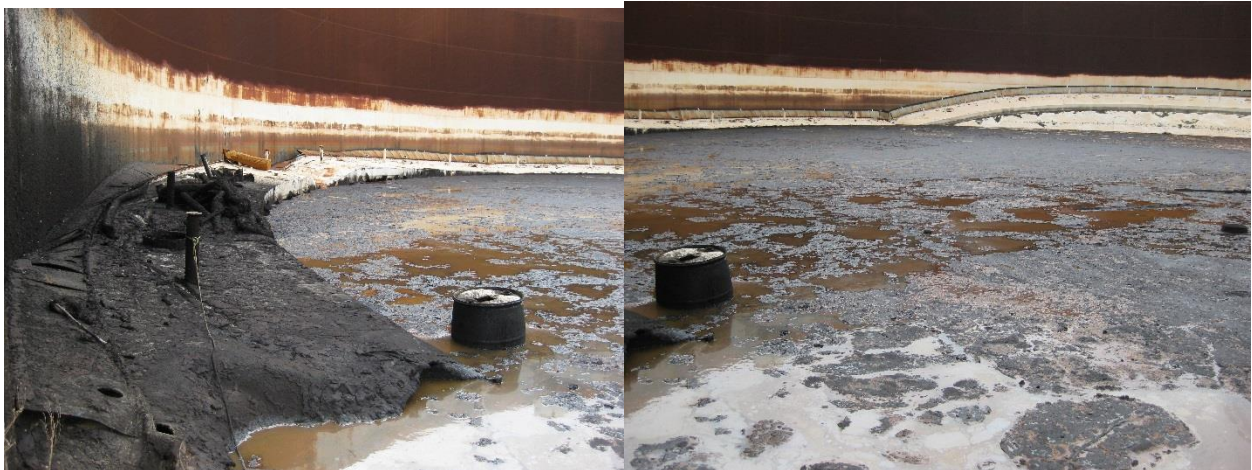
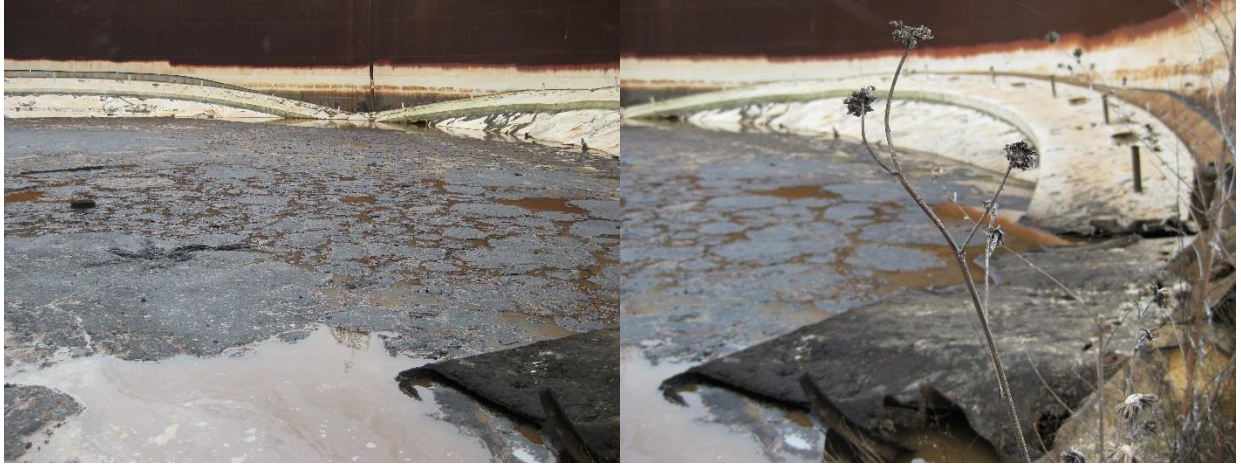
Tank 30: Interior view of Tank showing sludge and water and fallen portion of floating roof.

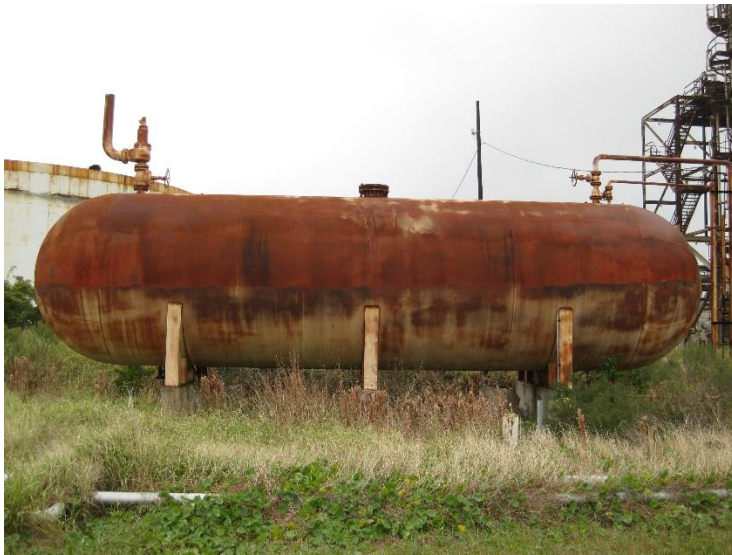
Butane Tank: Became a minor issue during Superior Crude spill when it was notice leaking. Supposedly has some thick hydrocarbon material in it.
